INSPECTION CONDITIONS

DATE OF INSPECTION: October 28/2008.
TIME OF INSPECTION: 1:00.
CLIENT NAME: Mr. & Mrs. Smith.
INSPECTION LOCATION:

1234 Any Street, My Town, California.
Robert Gaudreault.

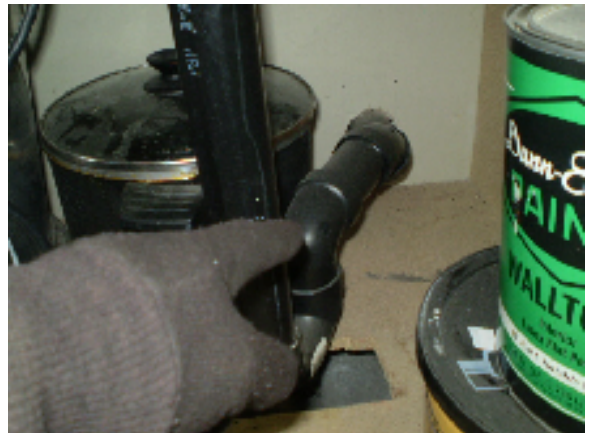
Needs Attention. Drain trap assembly at laundry sink drain is not installed per industry standards. This could result in waste siphoning from the trap thus allowing waste vapors to emit into interiors.

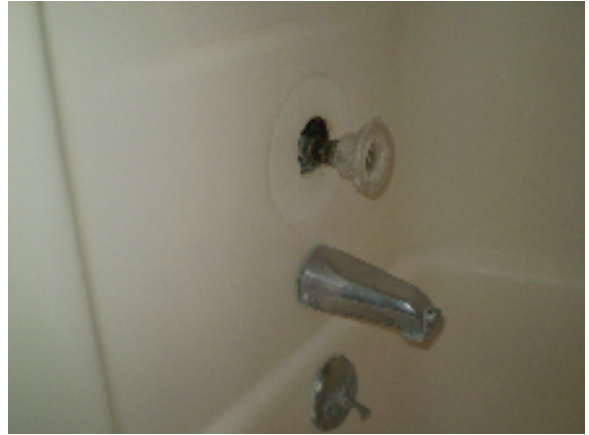
Functional.
Needs Attention.
Fixtures are not
operational at this time.
Also, seal around tub
spout poor. Prolonged
water infiltration into
substrate may be
present and result in
water damage in areas
that are not visible in
this type of
inspection.

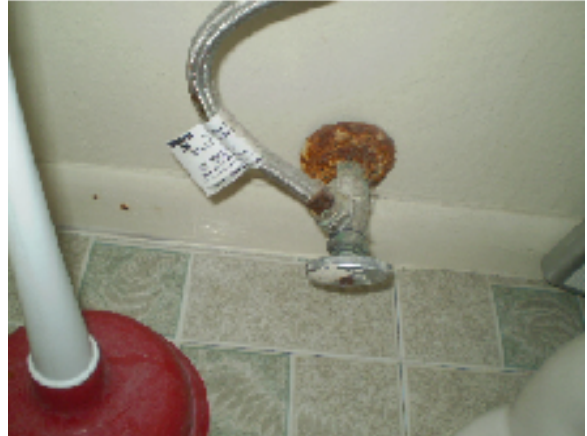
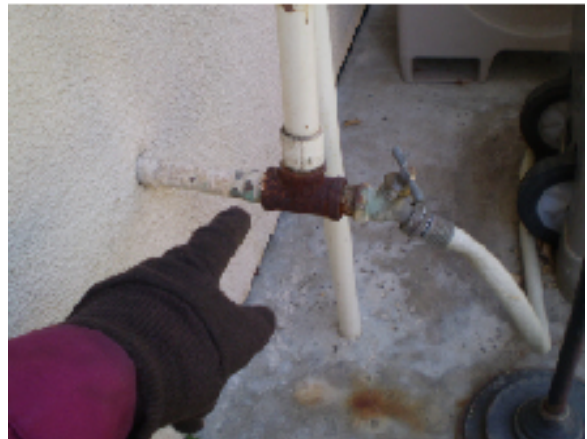
Needs Attention.
Overall visible sections of water pipes appear serviceable however, older angle stop shut off valves noted to interior plumbing fixtures. Client should understand that these older type valves do tend to leak, especially when operated. Consider upgrades. Also, Copper to Galvanized piping contact is noted in areas without the appropriate buffer between the two metals, such as exterior hose bib. Corrections to these areas is recommended. This can cause corrosion as the two types of material are not compatible.

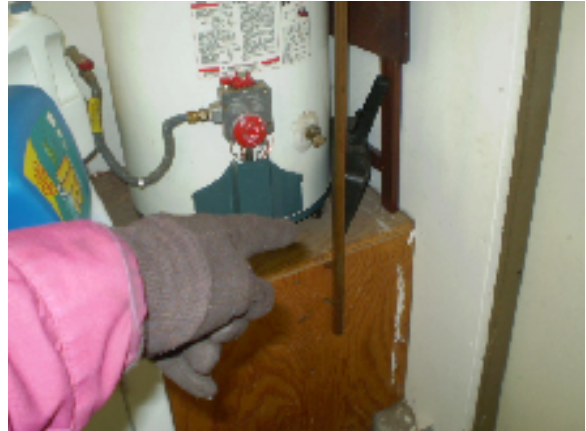
LOCATION: Garage.
TYPE: Gas.
SIZE: 40 Gallons.
AGE: 3 years.
CONDITION: Needs Attention. The pressure relief valve drain line is missing or ends prematurely. This is a safety issue. It is recommend that this drain line be extended to a safe and required location.

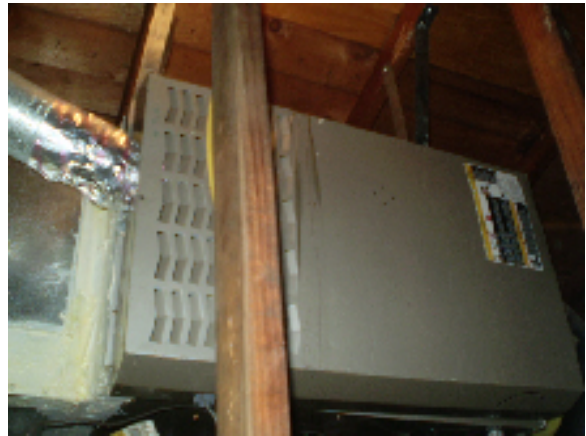
Needs Attention. Areas of concern are: This unit lacks adequate working platform from along the front to prevent ceiling damage when system is being serviced, unit cover does not fit and is loosely placed at this time. Flue pipe prevents it from fully closing, component should not be anchored from truss system as these framing units are not designed for additional weight and opening into attic space does not appear to be large enough to remove largest part of heater.

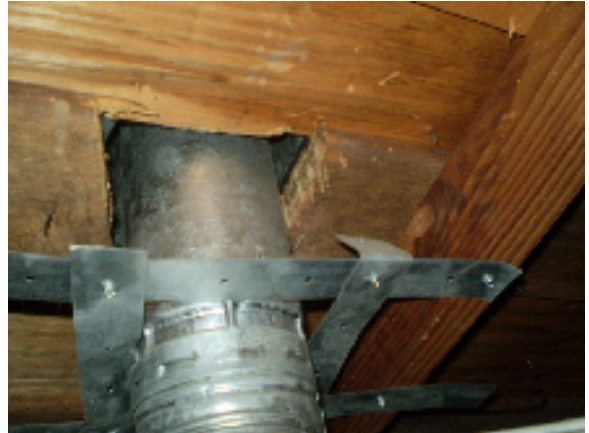
Functional.
Non Functional due to safety concerns: There is inadequate clearance observed from around the vent flue pipe to combustible material that is nearby. In other words the vent pipe, which gets very hot, is touching or is too close to a combustible product. This is a fire hazard and should be corrected at this time.

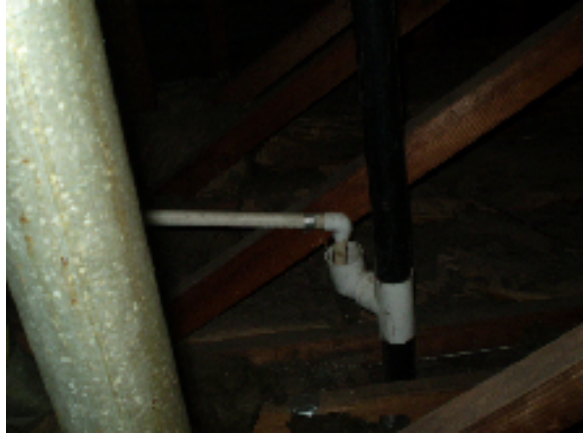
Non Functional due to health concerns. Improper installation of condensate drain pipe observed. Condensate drain line exiting the evaporator unit in attic space empties into a PVC drain line. When connected with the sanitary sewer, the possibility of bacterial contamination is present. Waste fumes from the sewer system could enter the unit. This situation contributed to Leigonaires disease some years ago in Philadelphia.

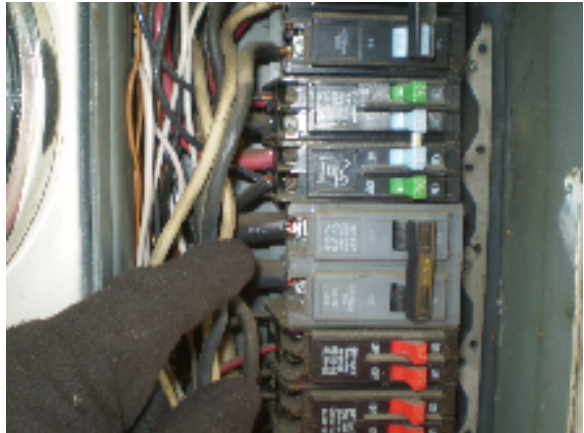
LOCATION: Exterior right side.
AMPERAGE: 100.
CONDITION: Non Functional due to safety concerns. There is more than one wire connected to a single breaker. This is referred to as double tapping, which can result in a poor connection between the wiring and the breaker lug. It can also cause over-loading of the circuit to the breaker. Corrections are recommended by a licensed electrical contractor at this time to prevent any possibility of future malfunctions. The conductors that are double tapped are under sized in ratio to over current protector which could cause electrical wires to overheat and pose a fire hazard.

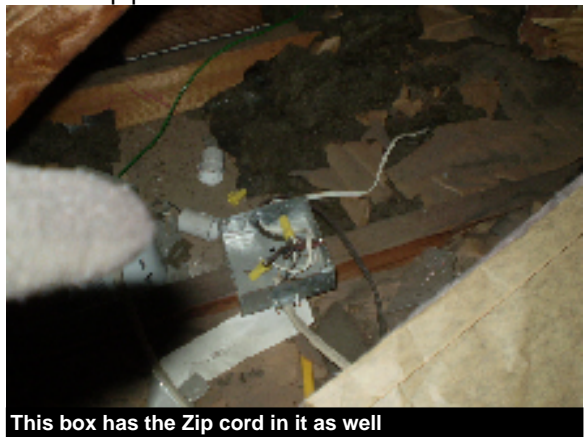
CONDITION: Visible wiring indicates plastic insulated copper conductors primarily within metal flexible, rigid conduit pipe/nonmetallic flexible conduits. Non Functional. Due to safety concerns. For the most part supply wiring appears serviceable however, Junction box or pull box cover(s) missing at some of the electrical boxes leaving wires exposed, such as attic space and Z power cord, which is simply a lamp extension cord, such as in attic space, is used to provide permanent 110 power.

This box has the Zip cord in it as well

This is a fire hazard and should be corrected at this time by a licensed and insured electrician.

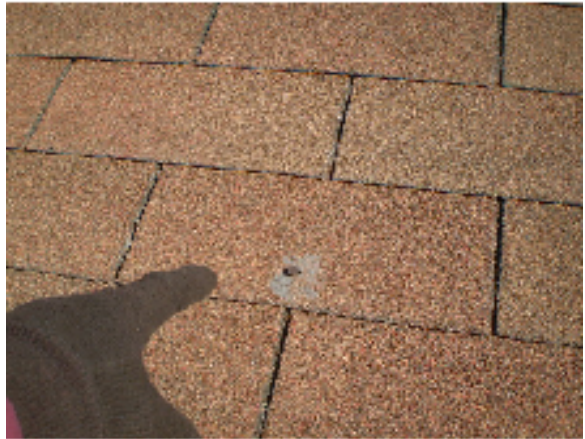
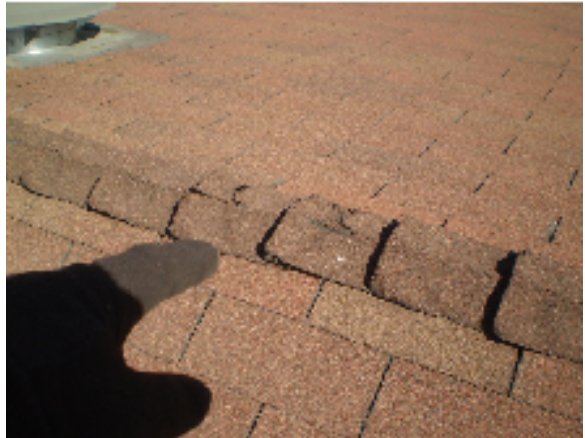
Needs Attention.
Areas of concern are as such: Deteriorated ridge cap observed. The ridge cap is that portion of roof material that folds over the uppermost section of roof system. In its current state it is damaged and deteriorated and poses potential leakage, cracked shingles noted throughout system and Nail heads/ Fasteners are protruding from the roof surface in general areas. These nail heads can eventually rust and pop up and pose a future leak issue. A licensed roofing contractor should be consulted to make further evaluation and/or repairs as needed.

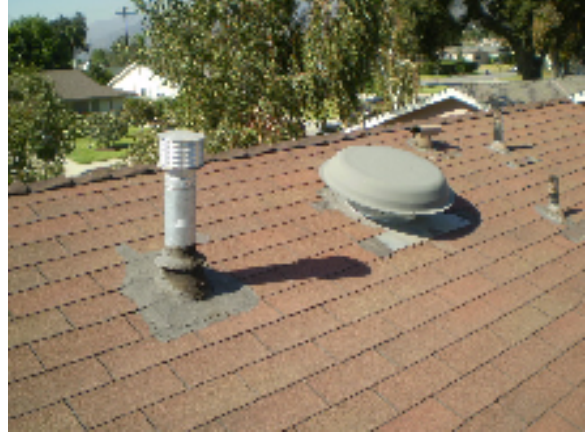
Non Functional. Overall collar flashings are poorly installed or constructed and more than likely not a water tight seal.

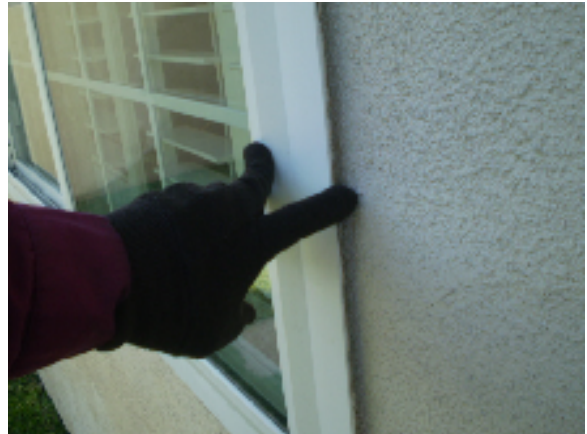
CONDITION: Needs Attention. Flush fin windows are not adequately sealed and may be a source of water infiltration. Consult a qualified licensed window installer for improvements.

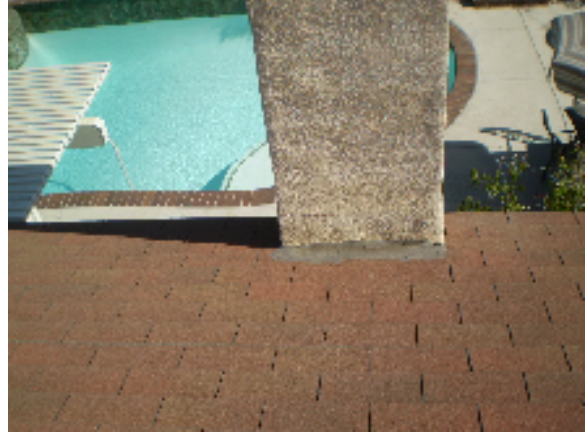
Needs Attention. Flashing around chimney where it meets roof line is in poor condition. Corrections recommended to ensure a water tight seal.

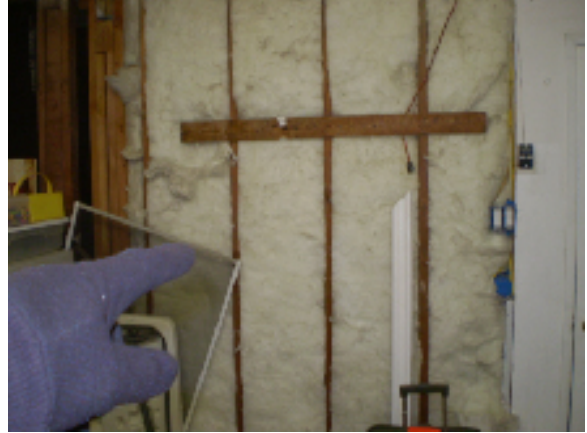
Needs Attention.
Drywall is missing from between the garage and living space thus compromising the needed fire barrier. Suggest repairs at this time.

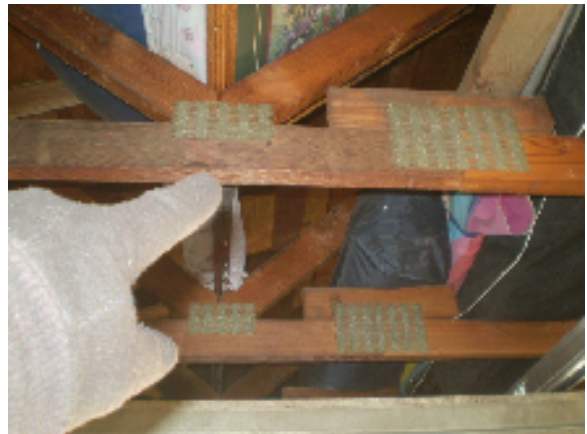
Needs Attention.
Damaged truss noted. Bottom cord appears to be split. Consult a qualified truss company for repairs. NOTE: Suggest that items not be stored on truss system as it is not designed for additional weight.

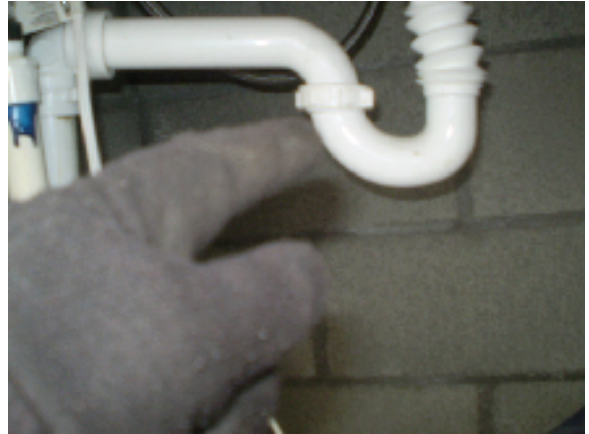
BBQs are not generally part of this inspection though it should be mentioned that there is a nonstandard drain assembly to this sink.

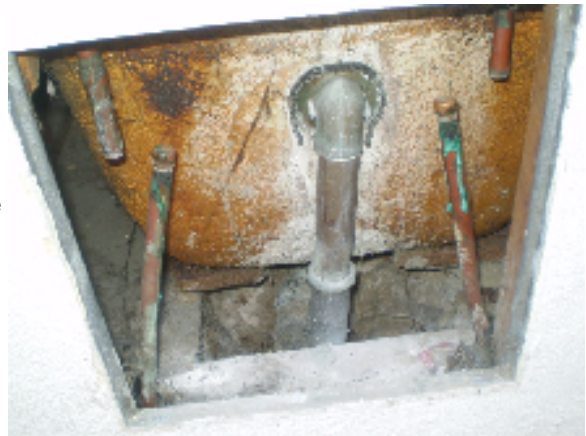
Repair any copper to galvanized contact, such as at back of dwelling, improve drainage of laundry sink and exterior sink and some improvements are needed to water heater. Also suggest upgrading angle stop valves. Contact a licensed plumber for these repairs. Fixtures pipe feed to master tub have been capped off at this time. Consult seller as to history.
